# LAKE TŪTIRA WATER QUALITY

Lake Tūtira, 40km north of Napier, has been affected by poor water quality for decades - the first algal bloom was recorded in 1957. This is not an overnight problem, and there is no single cause. Many attempts have been made since the 1970s to improve the lake, and research continues today to find a sustainable, long-term solution.

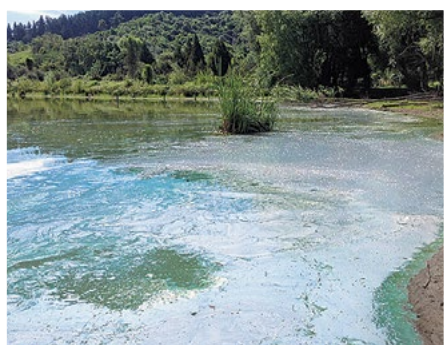
## WHAT CAUSES ALGAL BLOOMS?

Algae are microscopic organisms which occur naturally in fresh water lakes and rivers. We can only see algal populations when they quickly expand or 'bloom', causing the water to change colour.

Long, warm Hawke's Bay summers heat the top layers of Lake Tūtira, where there are plenty of nutrients, creating perfect conditions for algal populations to bloom.

Ceratium algae turns the water brown, but is not toxic. Cyanobacteria algae turns the water green or blue-green, with foamy scum at the edge and an unpleasant smell. It can turn toxic - always treat it as so.

The top layer of warm water also prevents oxygen reaching deeper water and contributes to increased water alkalinity - a sometimes fatal combination for trout and tuna (eels).
