Te Ngaru Stream
Flood Hazard Study

September 2005
AM 05/16
HBRC Plan Number 3794

Technical Report

Te Ngaru Catchment Flood Hazard Study

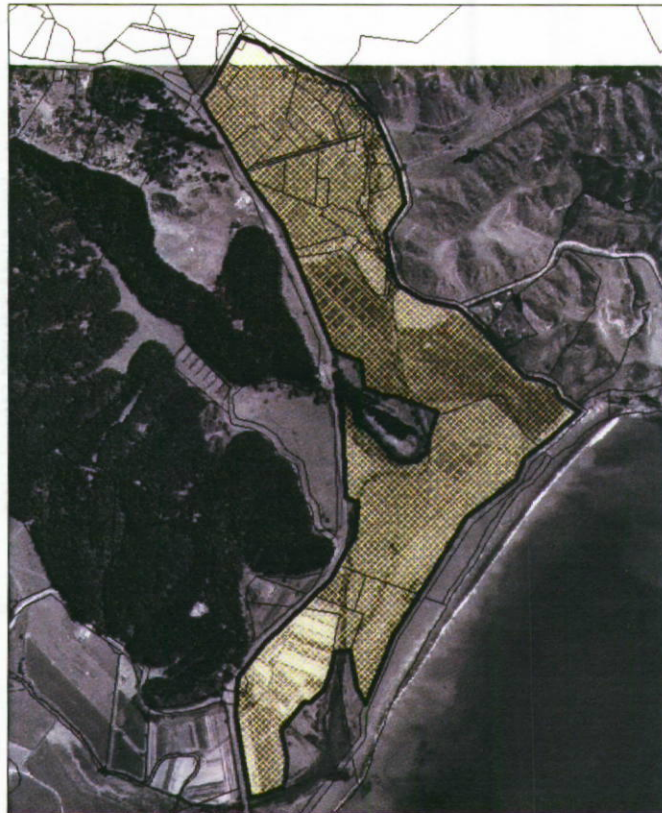
Figure 3: Te Ngaru Flood Control Scheme Rateable Area

The scheme assets that are maintained are the 3 km section of stream from the coast up to Tangoio Settlement Road. The rating area for the scheme is shown in Figure 3

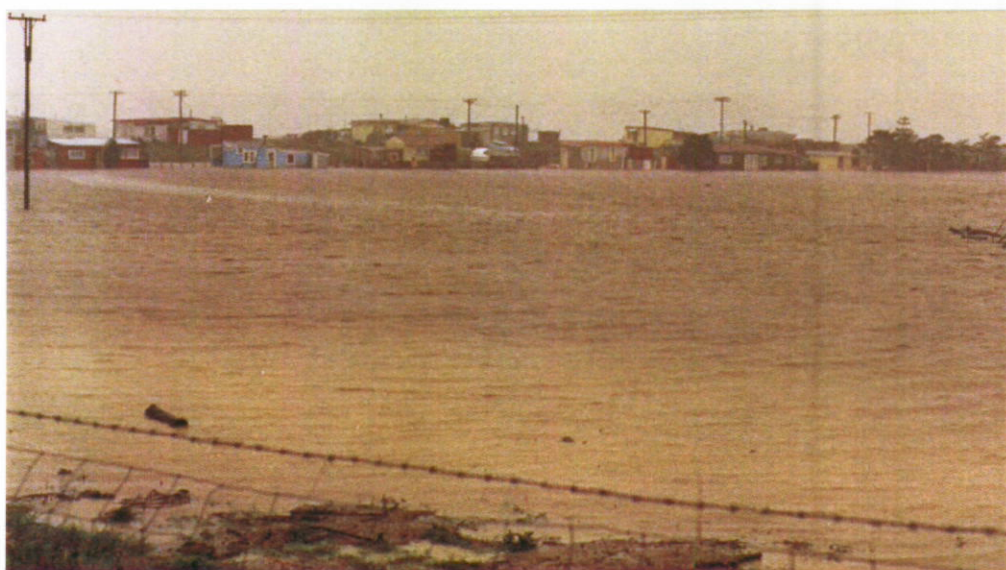
Figure 4: March 1988 – Cyclone Bola, Te Ngaru Stream Floodplain

The Te Ngaru Catchment had received about 310 mm of rain for the month of February 1988, resulting in a wet catchment. Over the 6 days from March 5 to 11, 1988, the Te Ngaru received another 805 mm. On March 8, there was 202 mm of rain, followed by another 223 mm on March 9, then followed by 188 mm on March 10. The floodwaters can be seen in Figure 4, while the silt deposits can be seen in Figure 5 and Figure 6.

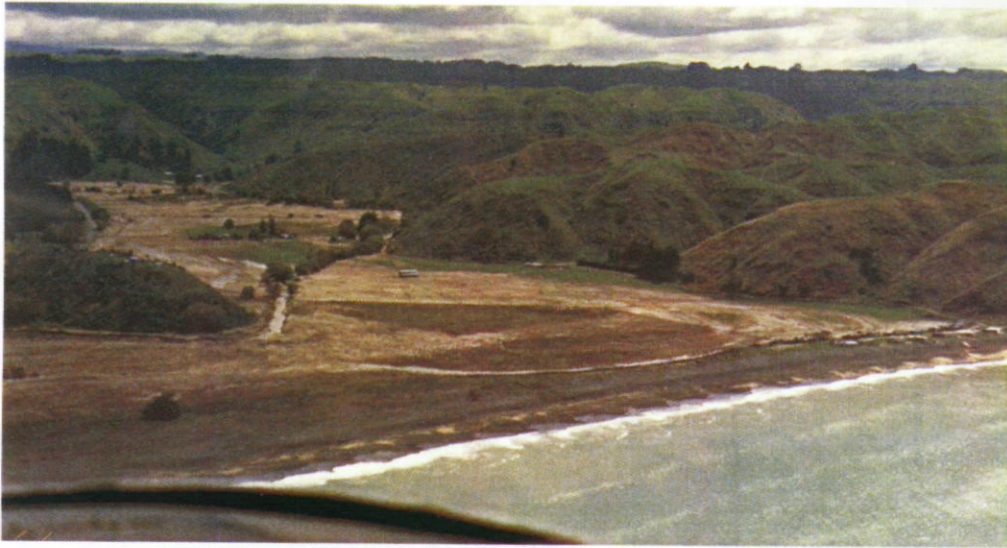
Figure 5: March 1988 – After Cyclone Bola, Te Ngaru Stream Floodplain showing silt deposits

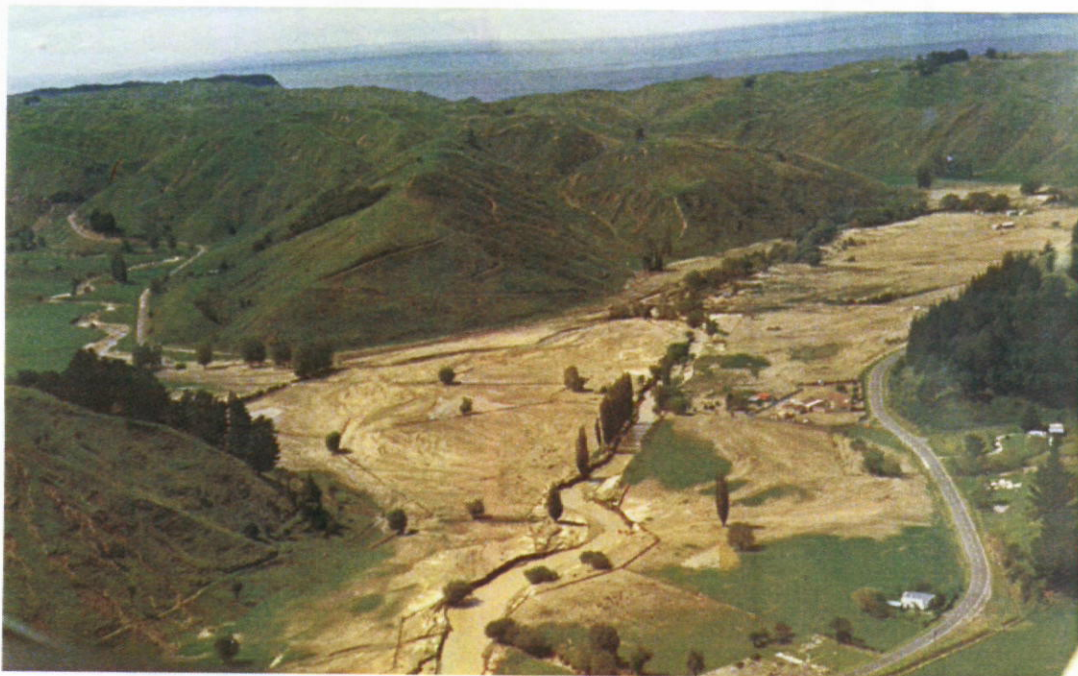
Figure 6: March 1988 – After Cyclone Bola, Te Ngaru Stream Floodplain showing silt deposits

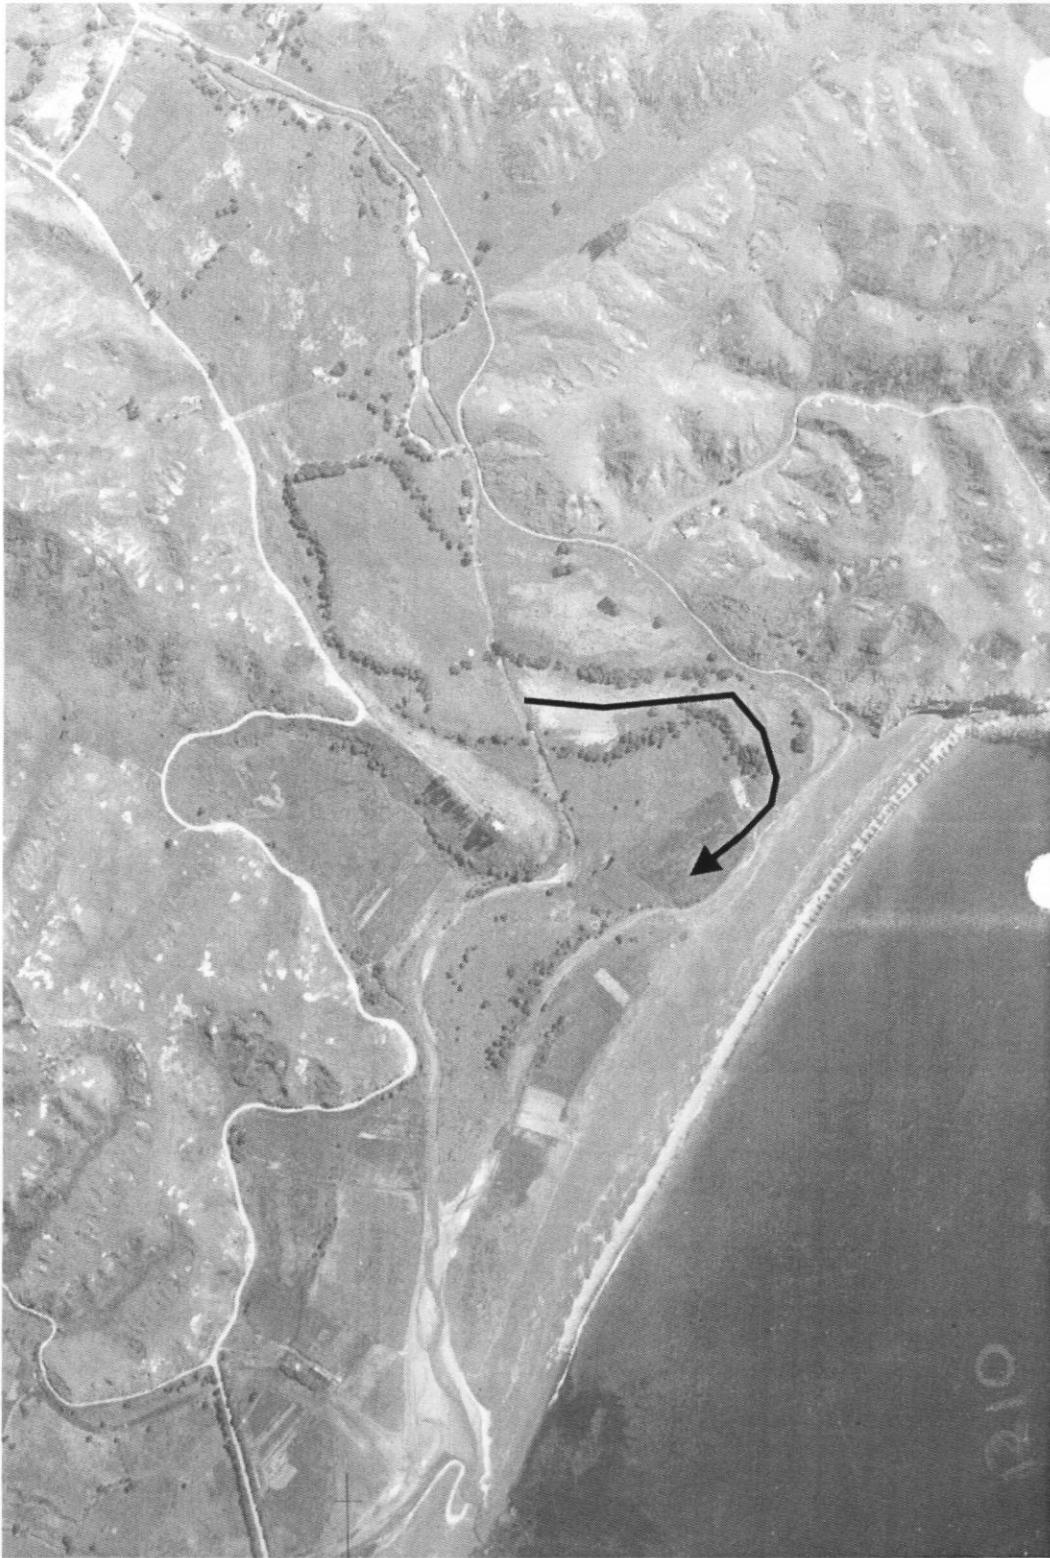
Figure 7: Air photo March 1934 (arrow showing likely flow path through treed area)

The following set of air photos is from HBRC archives, showing the change to the lower floodplain over the years. The trees in the 1934 photo show the original flow path that the out of channel flow may have taken during a flood. The subsequent photos show how the area has gradually been developed for farming.

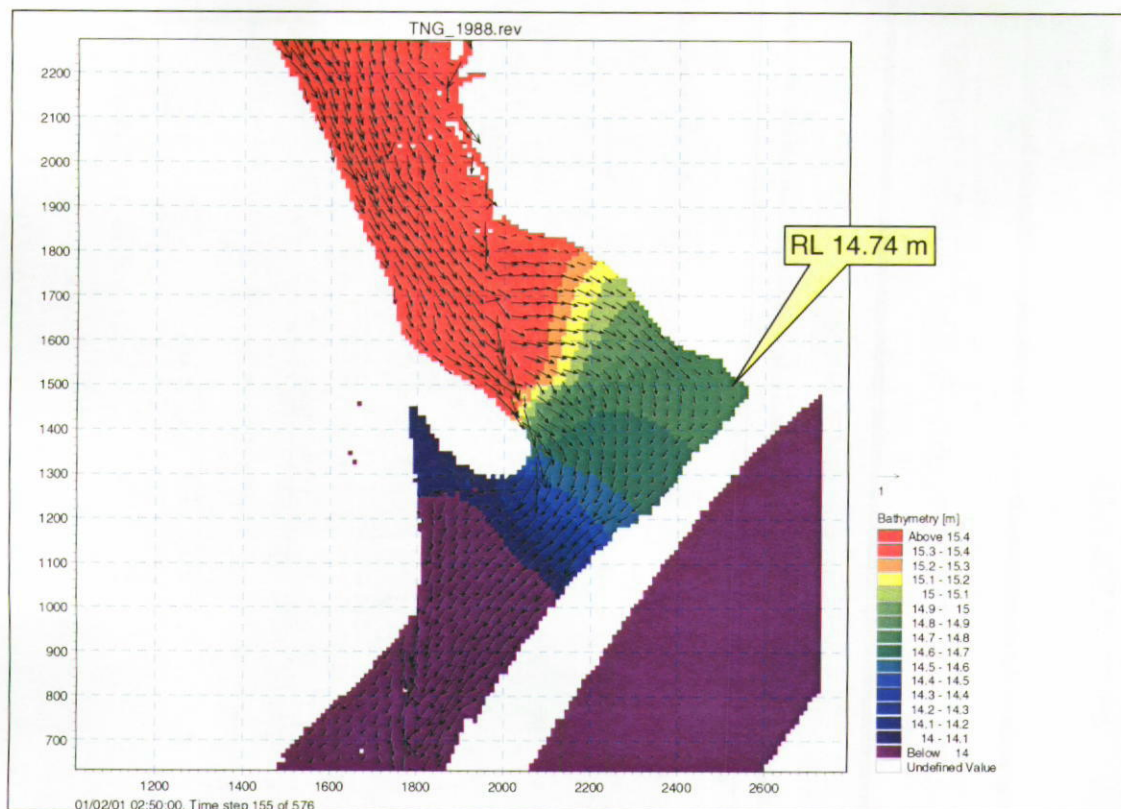
The hydrodynamic model was run with the hydrograph generated from the hydrologic model for the March 1988 storm (Cyclone Bola). The results from the model show the maximum water level at same location of above photos to be RL 14.74 m.

Figure 14: 2D Hydrodynamic Model Results for Bola (March 88) – Water Levels and Velocity Vectors

The above results show that the model is able to predict (within a level of accuracy) the water levels on the floodplain, based on a given rainfall event.

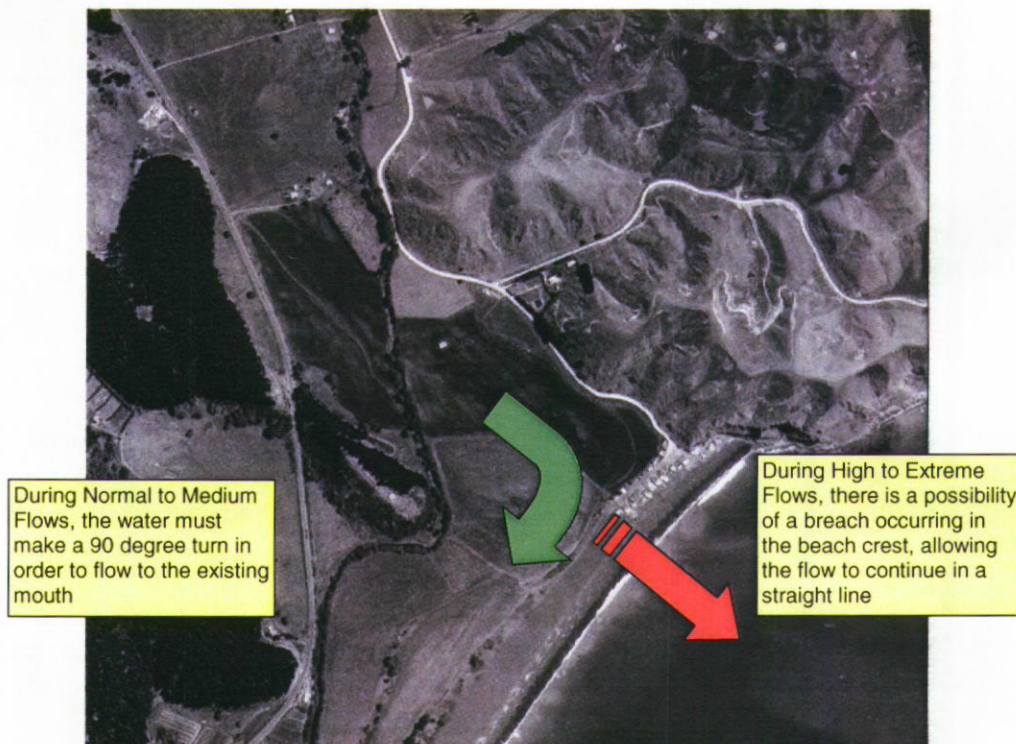
Figure 16: Direction Change on Te Ngaru Floodplain

The following figure shows the direction change that the floodwaters must take at the beach, as well as the potential overflow in the event of an extreme event.

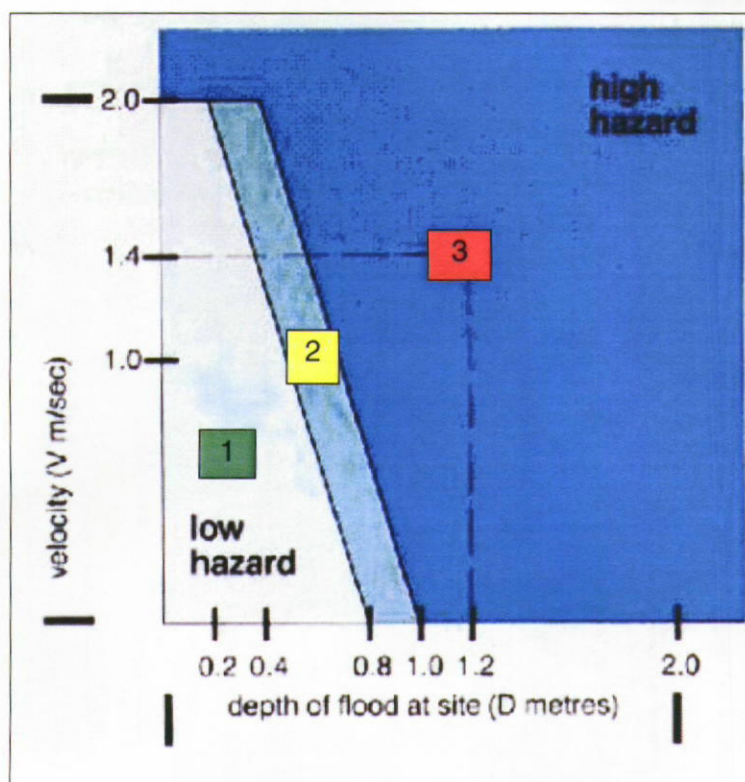
An assessment of the hazard on the Te Ngaru floodplain was made using the criteria developed from the New South Wales Government Floodplain Management Manual (2001), which uses the depth multiplied by velocity criteria. Figure 18 shows the three levels delineated. Level 1 occurs with shallow water and low velocity, Level 2 occurs with either shallow water and medium velocity, or deeper water and low velocity, while Level 3 occurs with shallow to medium deep water with high velocity, or deep water with low to medium velocity. Values for the 3 levels are calculated for all grid points in the 2D hydrodynamic model.

Figure 18: Flood Hazard Assessment Levels

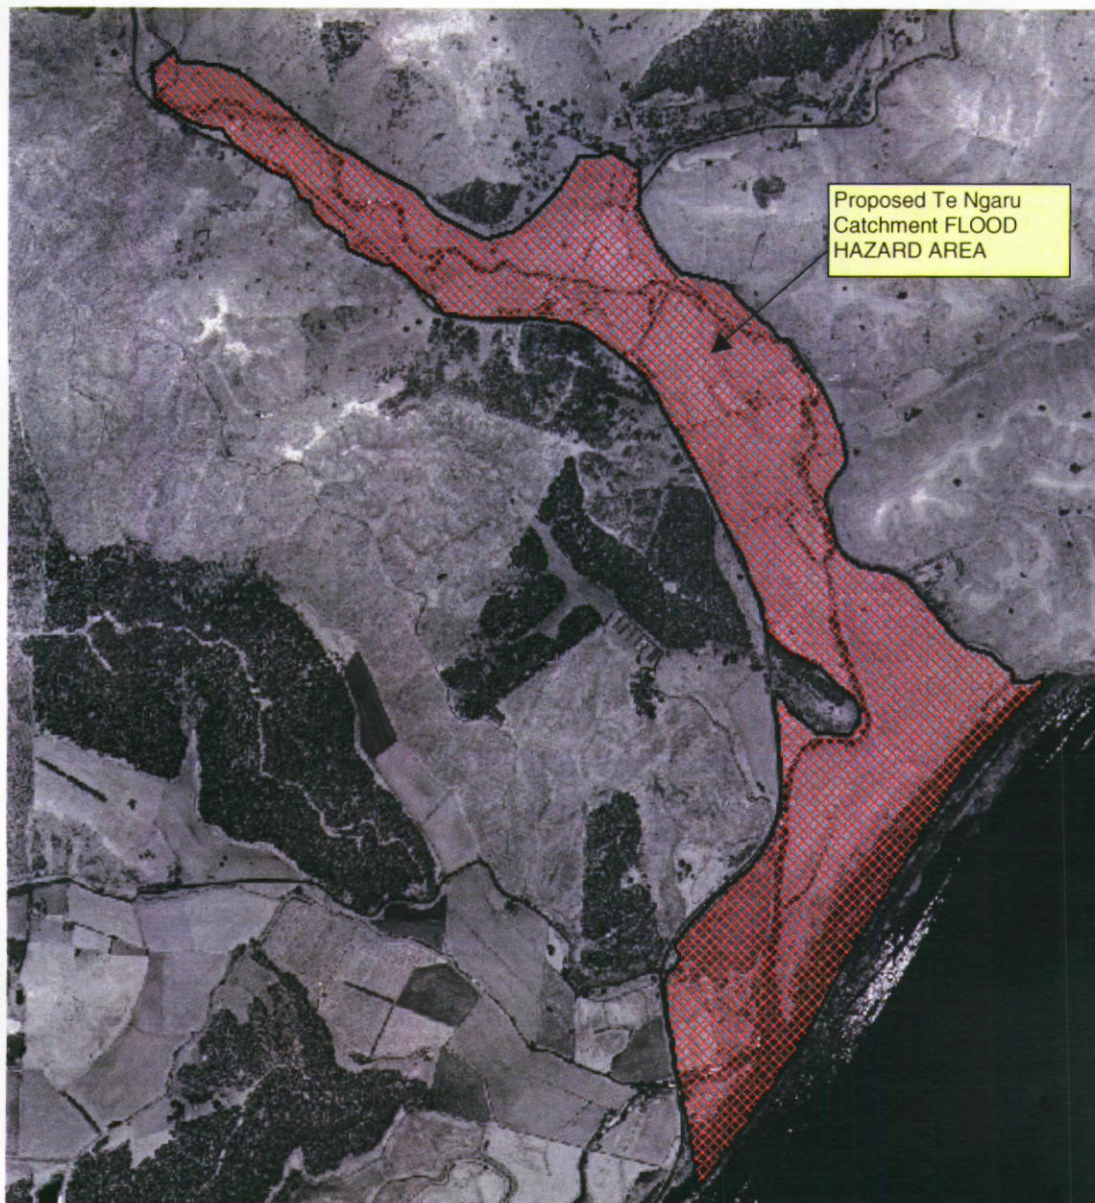
Figure 20: Te Ngaru Catchment Flood Hazard Area

The Te Ngaru Flood Hazard area shown in Figure 20 is based on the 100 year flood discharges. The variety of other discharge calculations shown in this analysis would result in essentially the same flood hazard extents. The difference between the different events is the depth of flooding.

Based on the potential flood hazard presented above. The following FLOOD HAZARD AREA is proposed for the Te Ngaru Floodplain.
